# Relative Performance Comparison Between Baseline Labyrinth and Dual-Brush Compressor Discharge Seals in a T-700 Engine Test

Prepared for the  
39th International Gas Turbine and Aeroengine Congress and Exposition  
sponsored by the American Society of Mechanical Engineers  
The Hague, Netherlands, June 13-16, 1994

1. AGENCY USE ONLY (Leave blank)	2. REPORT DATE October 1995	3. REPORT TYPE AND DATES COVERED Technical Memorandum		
4. TITLE AND SUBTITLE Relative Performance Comparison Between Baseline Labyrinth and Dual-Brush Compressor Discharge Seals in a T-700 Engine Test		5. FUNDING NUMBERS  WU-584-03-11 1L162211A47A

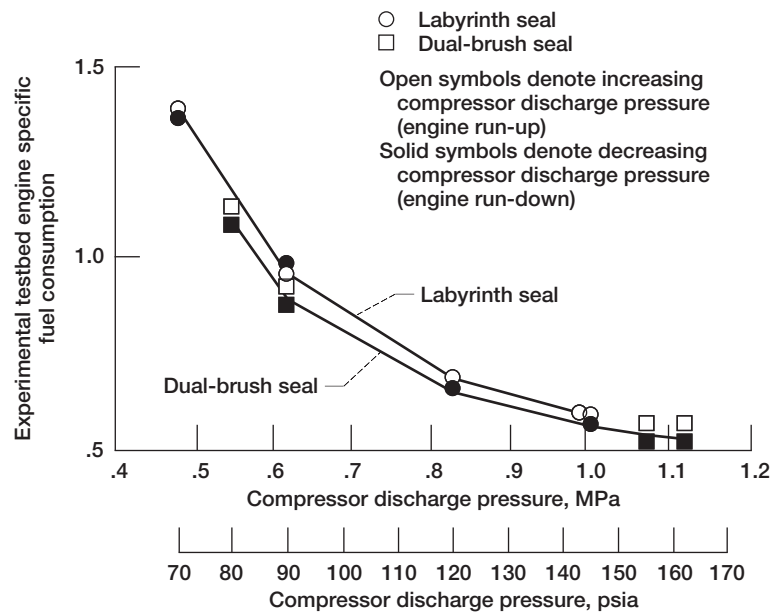
Figure 15.—Experimental testbed engine specific fuel consumption as a function of compressor discharge pressure with labyrinth and dual-brush seals.

efficiency. However, a decrease in experimental testbed engine specific fuel consumption (3 percent at compressor discharge pressures of 1 MPa (145 psi) to 5 percent at 0.62 MPa (90 psi)) was found (Fig. 15, Table IV). Variation of experimental testbed specific fuel consumption with horsepower is given in Fig. 16. To within the error estimates the performance increase is assumed to result from less leakage and enhanced distribution of secondary airflow through the engine.

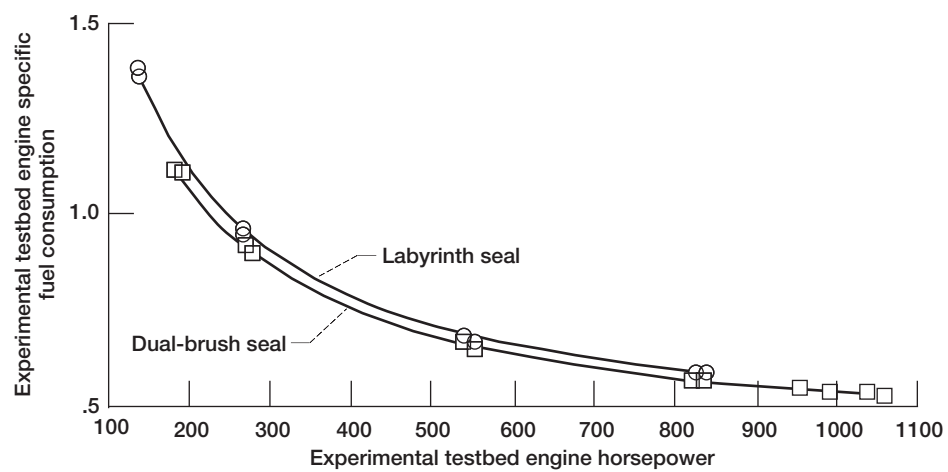
Figure 16.—Experimental testbed engine specific fuel consumption as a function of horsepower.
